CONTINUING ELIGIBILITY INSPECTION (CEI) REPORT
FOR FLOOD CONTROL PROJECTS

1. **Project Name:** Pa'auau Flood Control Project
2. **Date of Inspection:** November 13, 2002
3. **Inspection Personnel:**

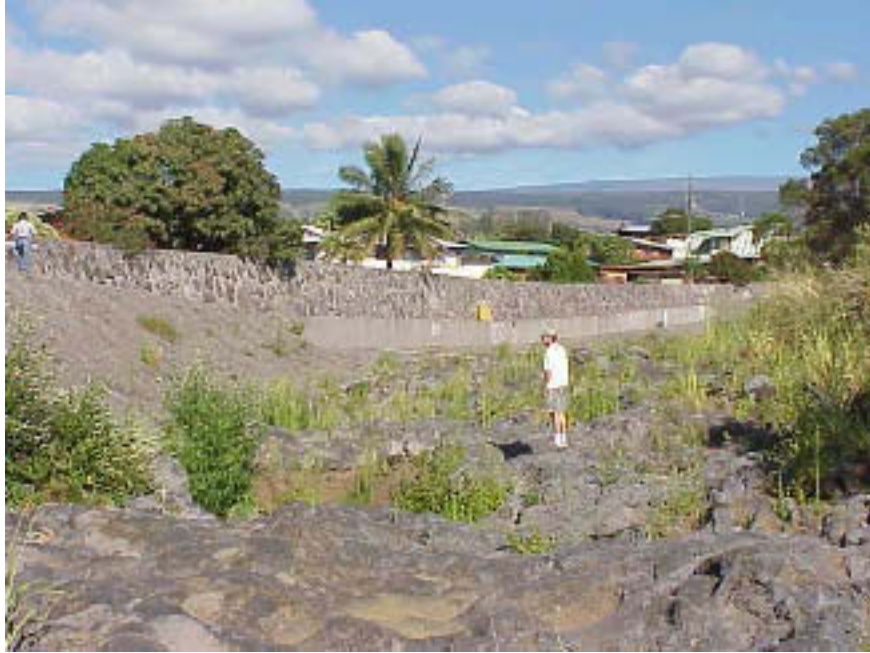
a. Sta. 7+75, Floodwall "E" right bank (RB), overview.

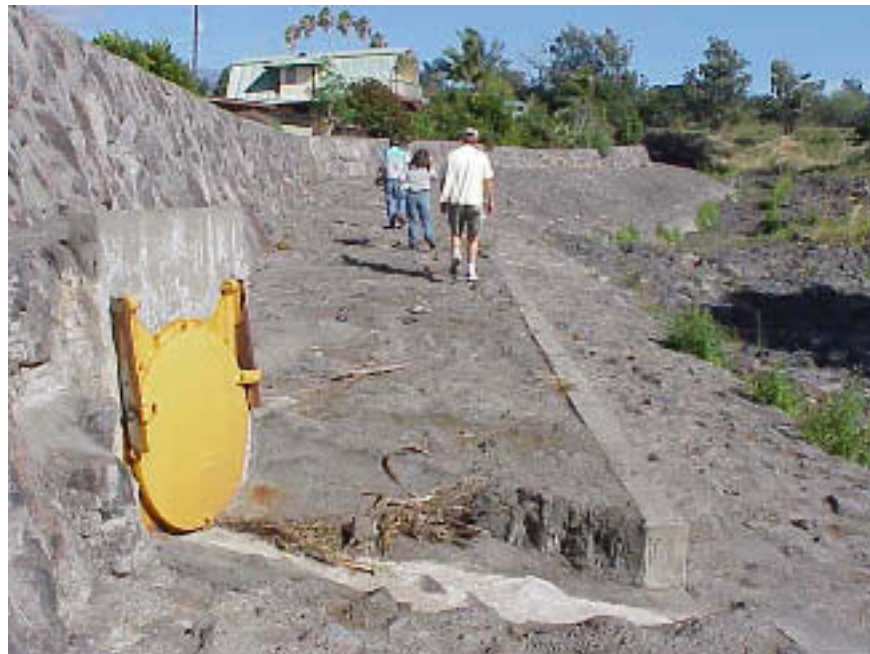
b. Sta. 10+00, Floodwall "E" RB, (typical of all flapgates) remove vegetation and debris, and lubricate flapgates.

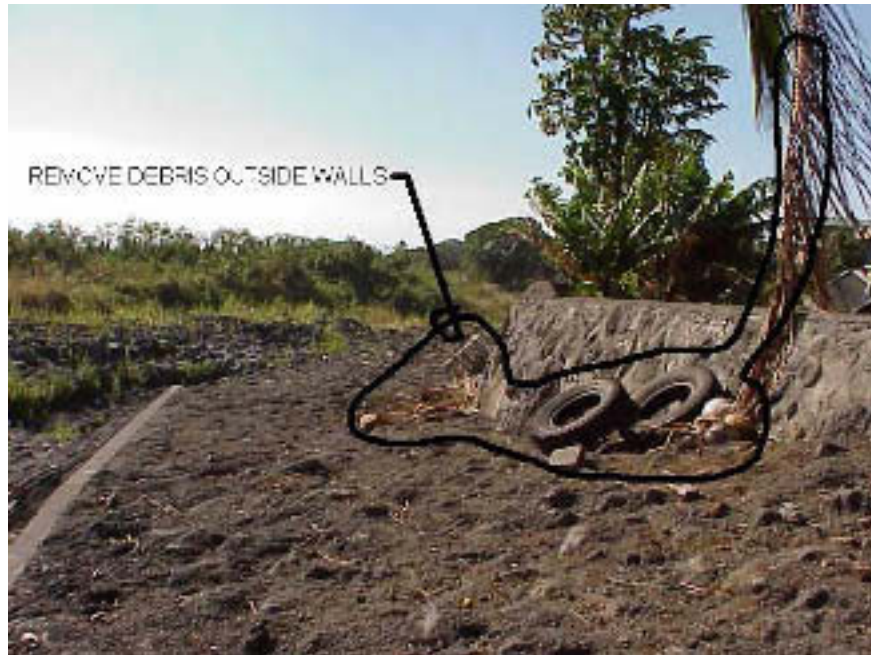
c. Sta. 14+50, RB between Floodwall "E" and "C", remove tires and other debris outside of walls.

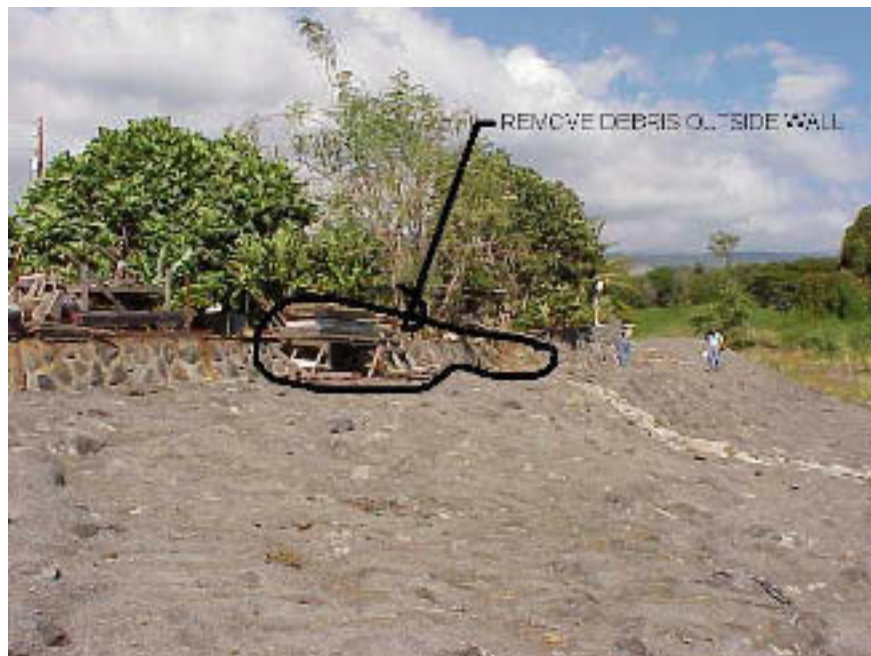
d. Sta. 23+50, Floodwall "B" RB, remove debris outside wall on grouted sideslope.

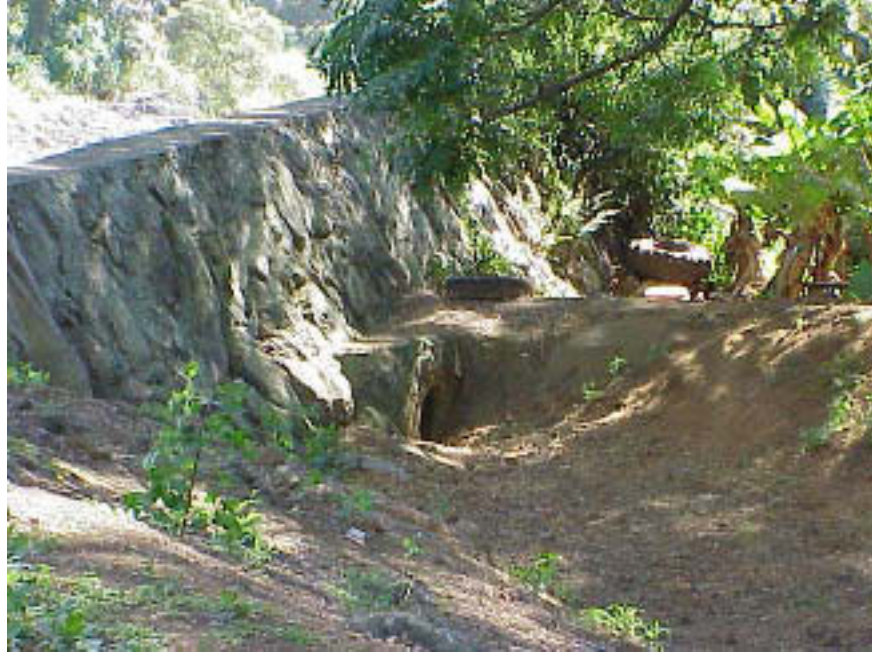
e. Sta. 25+00, RB upstream end of Floodwall "A", interior drainage overview.

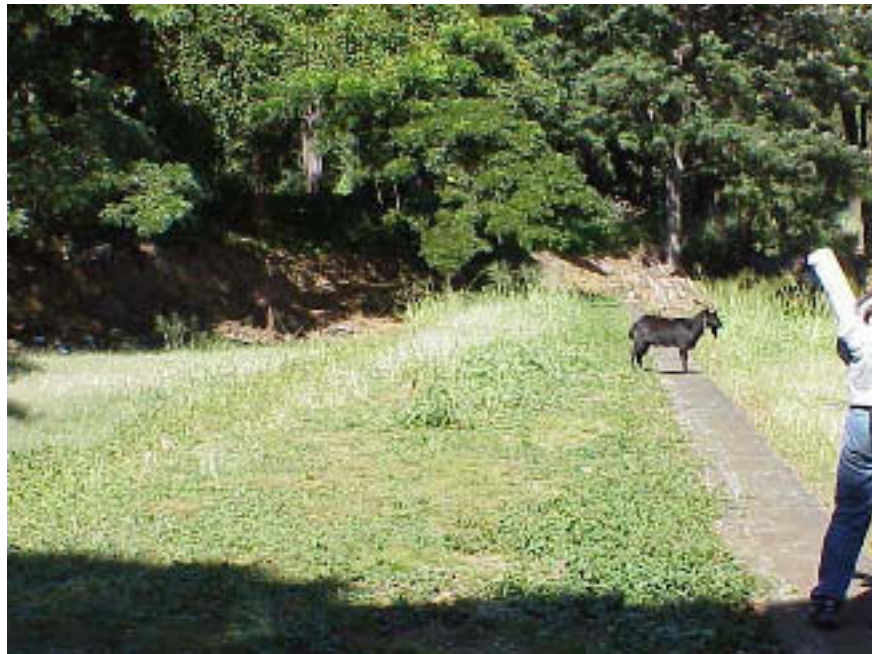
f. Sta. 25+00, RB 263 feet levee, overview.
